Information Item

Forcemain Inspection Program

Environment Committee: April 28, 2026

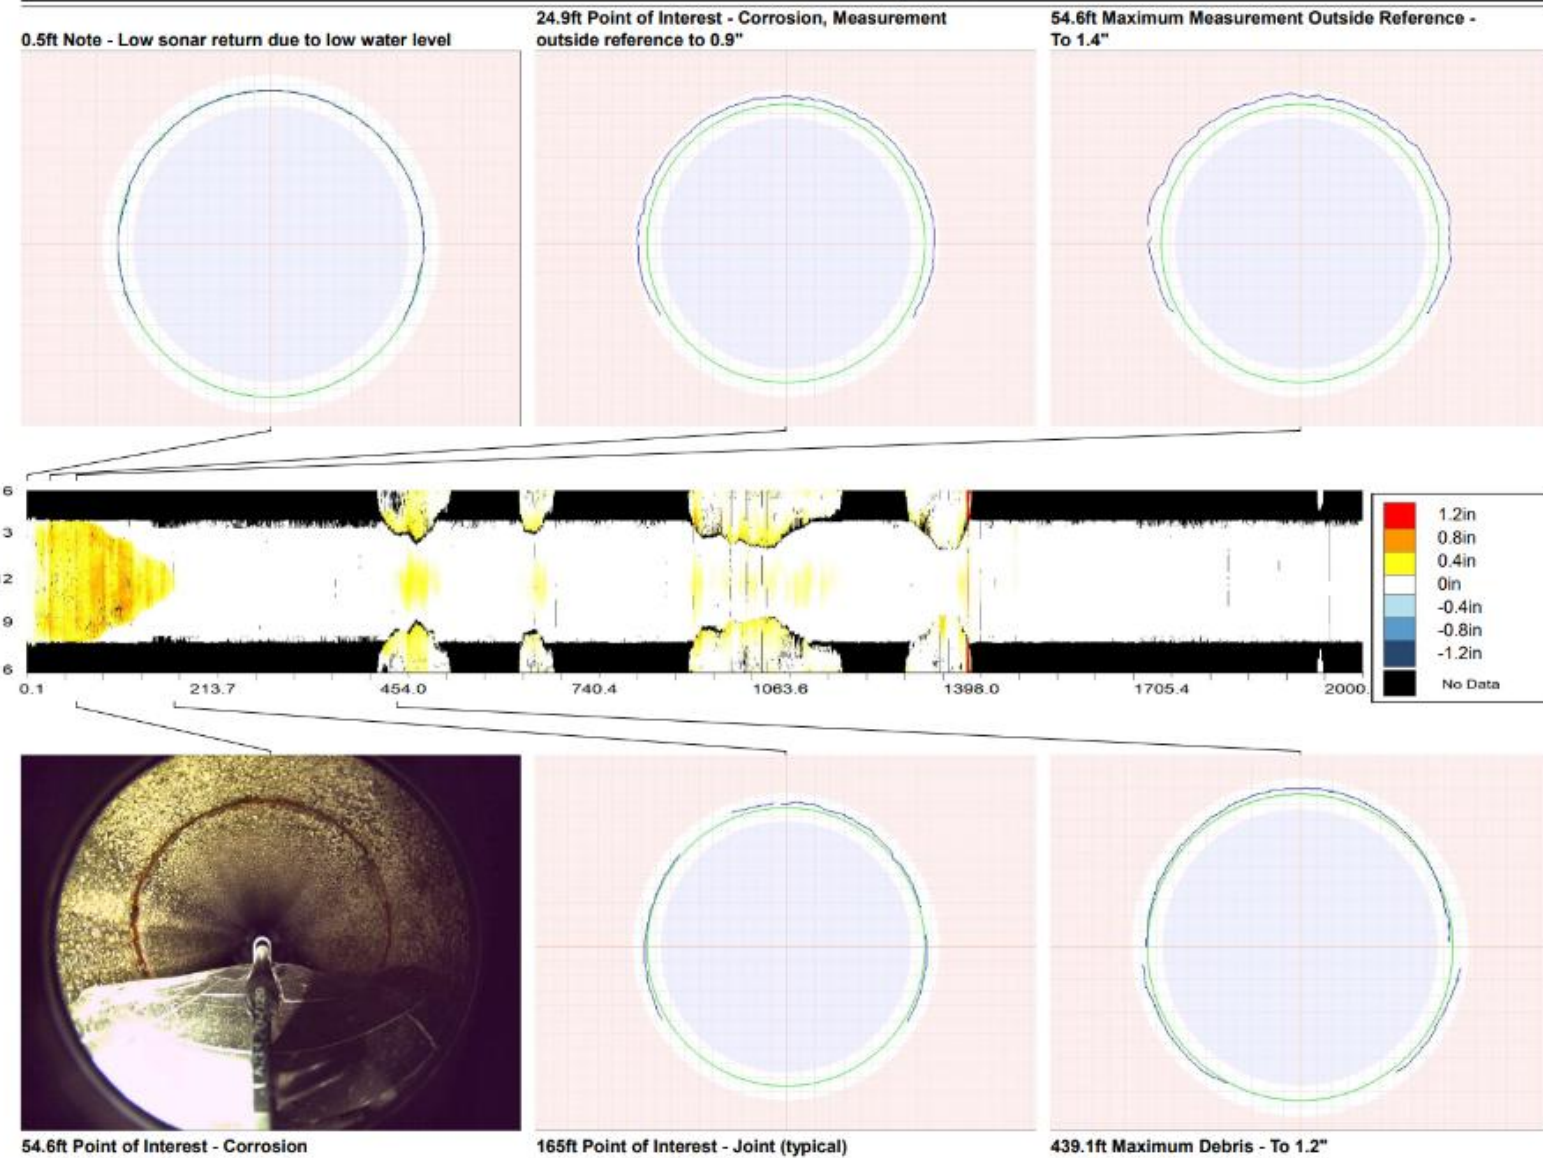
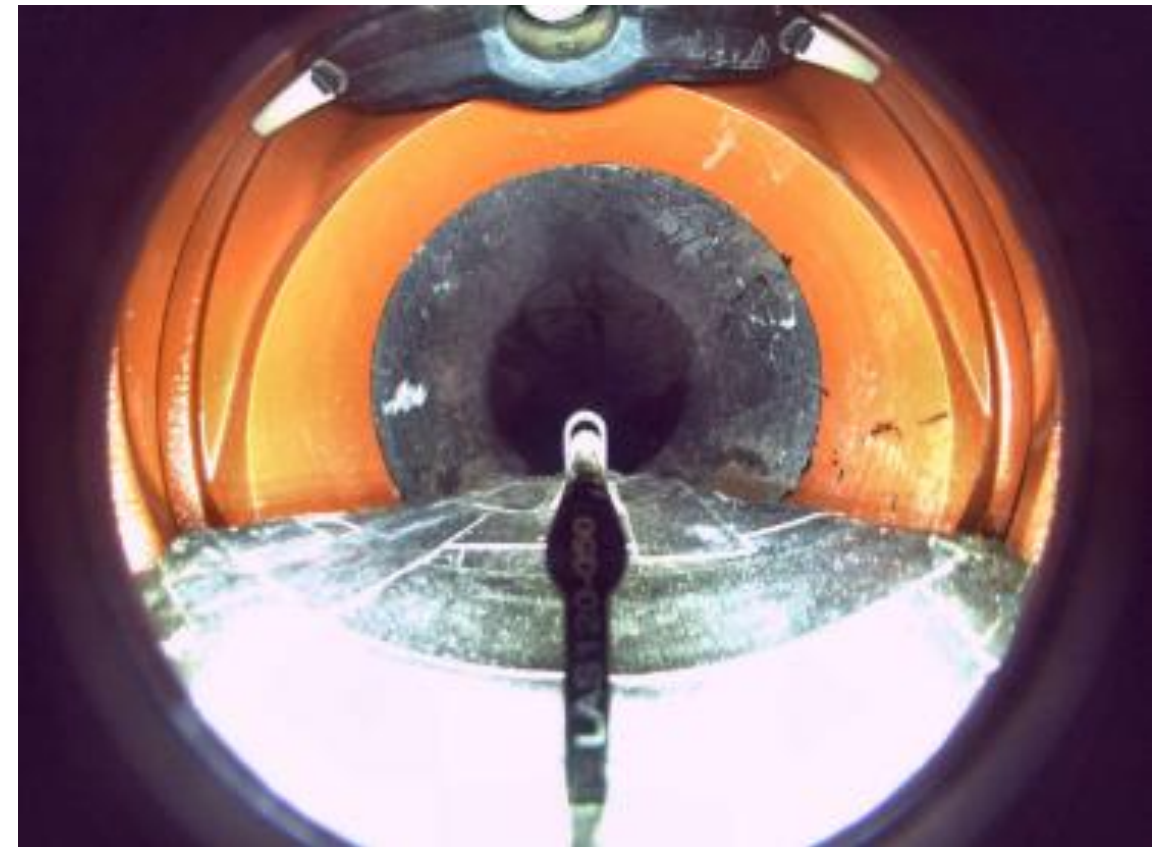
Observation Report

Laser/Sonar/CCTV Inspection Results

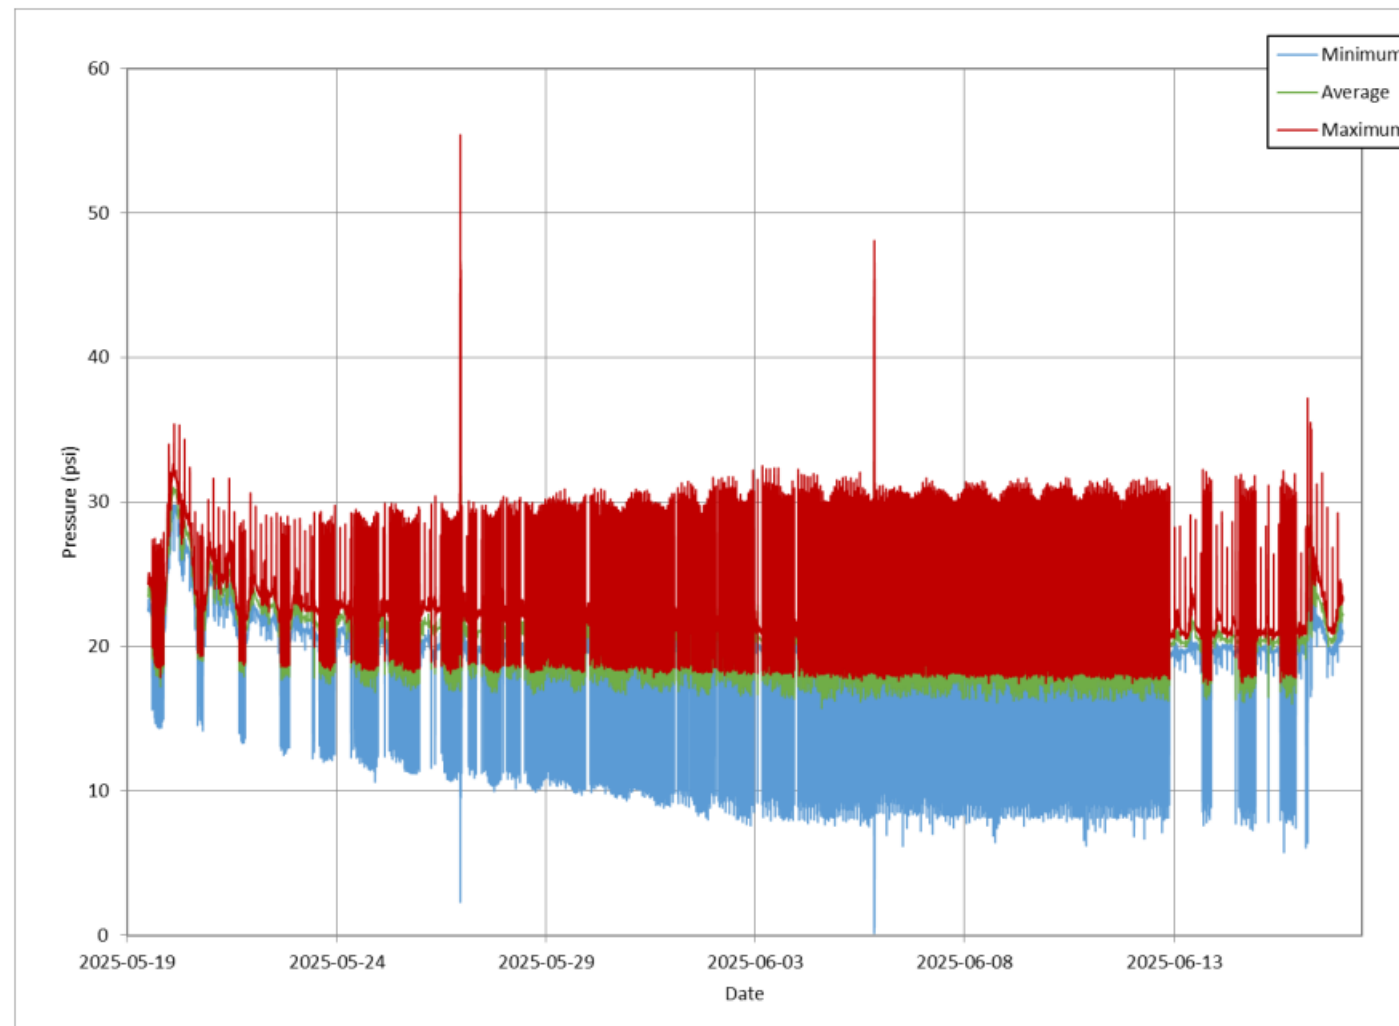
Figure 3.2: Pressure Recordings for 24-inch Golden Valley Force Main

Table 2.2: Summary of Inspected Pipes				
Pipeline	Diameter (inches)	Number of Inspected PCCP Pipes	Pipes with Broken Wire Wraps	Anomalous Pipes
Golden Valley/New Hope Force Main	24	580	30	4

Table 2.3: Summary of Pipes with Broken Wire Wraps					
Pipeline	Diameter (inches)	PCCP Length (feet)	Pipes with fewer than 25 Broken Wire Wraps	Pipes with 25 to 50 Broken Wire Wraps	Pipes with more than 50 Broken Wire Wraps
Golden Valley/New Hope Force Main	24	8,710	26	4	0

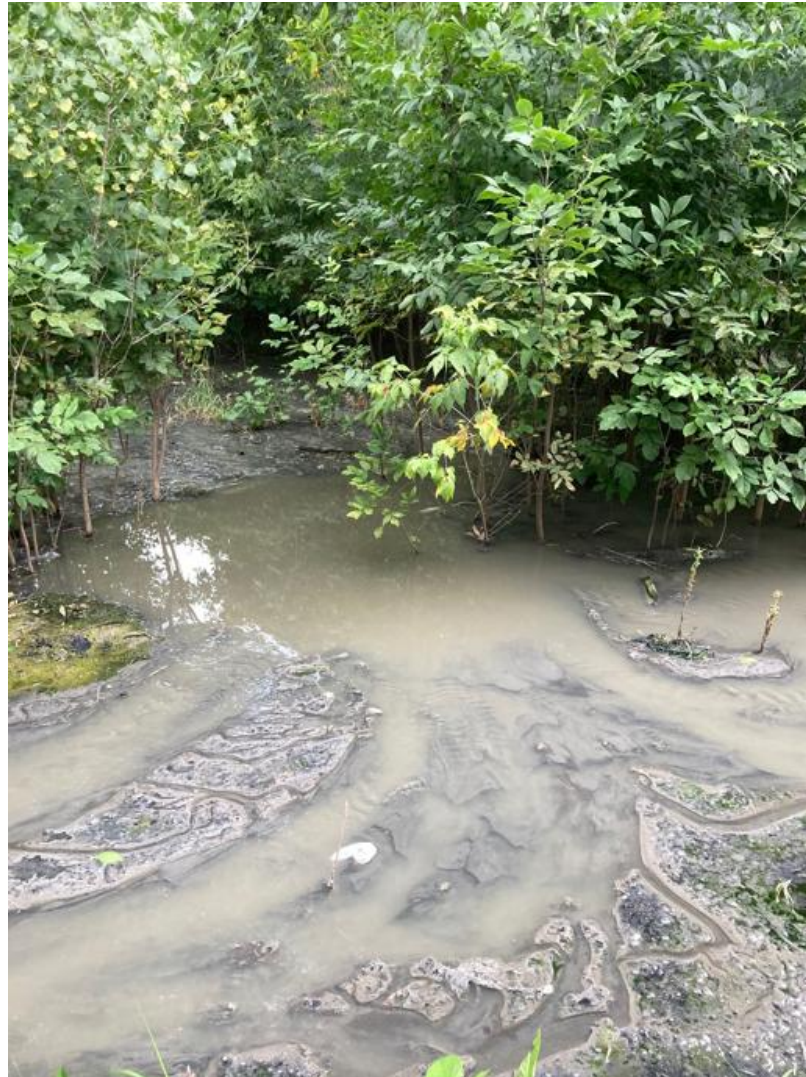
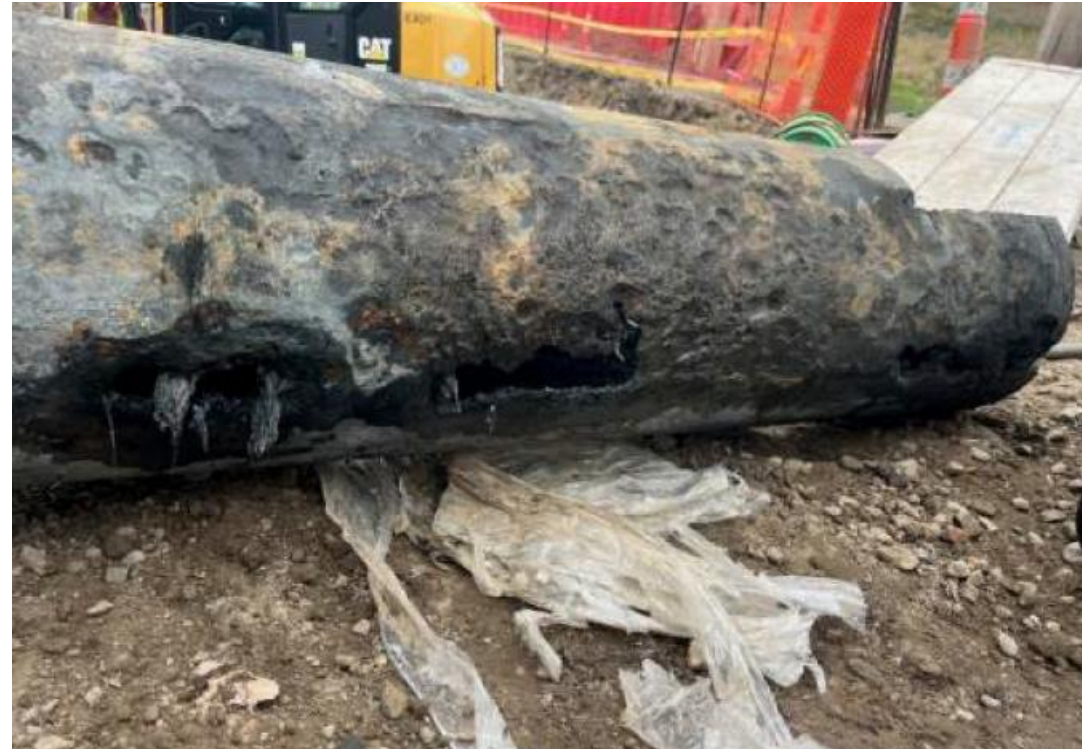
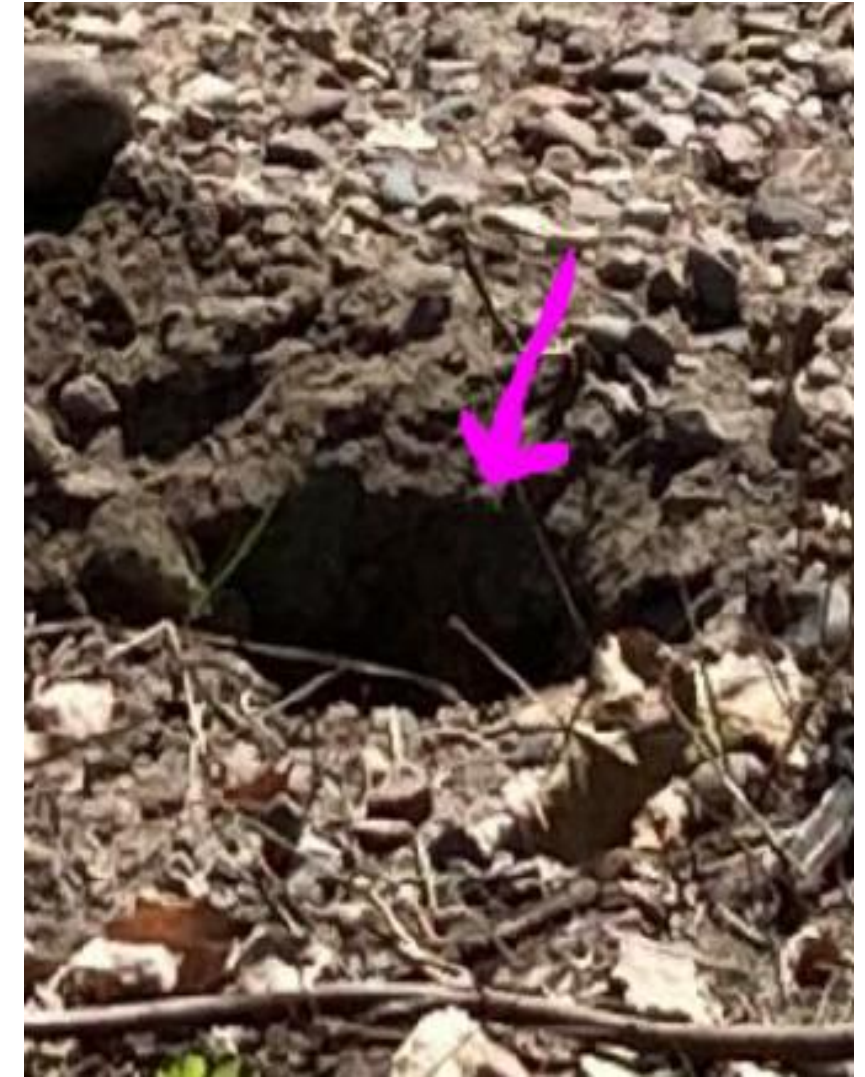
1-MH-401 Siphon Pipe Failure

- Locations of utilities crossing our DIP forcemains need to be identified.
- Existing corrosion protection systems need to be monitored and maintained. Program currently under development. (Future Information Item?).
- Insertion and retrieval of Pipers tool is easy compared to other technologies.
- Cost of this technology is a fraction of the other technologies used, but it is only good for DIP

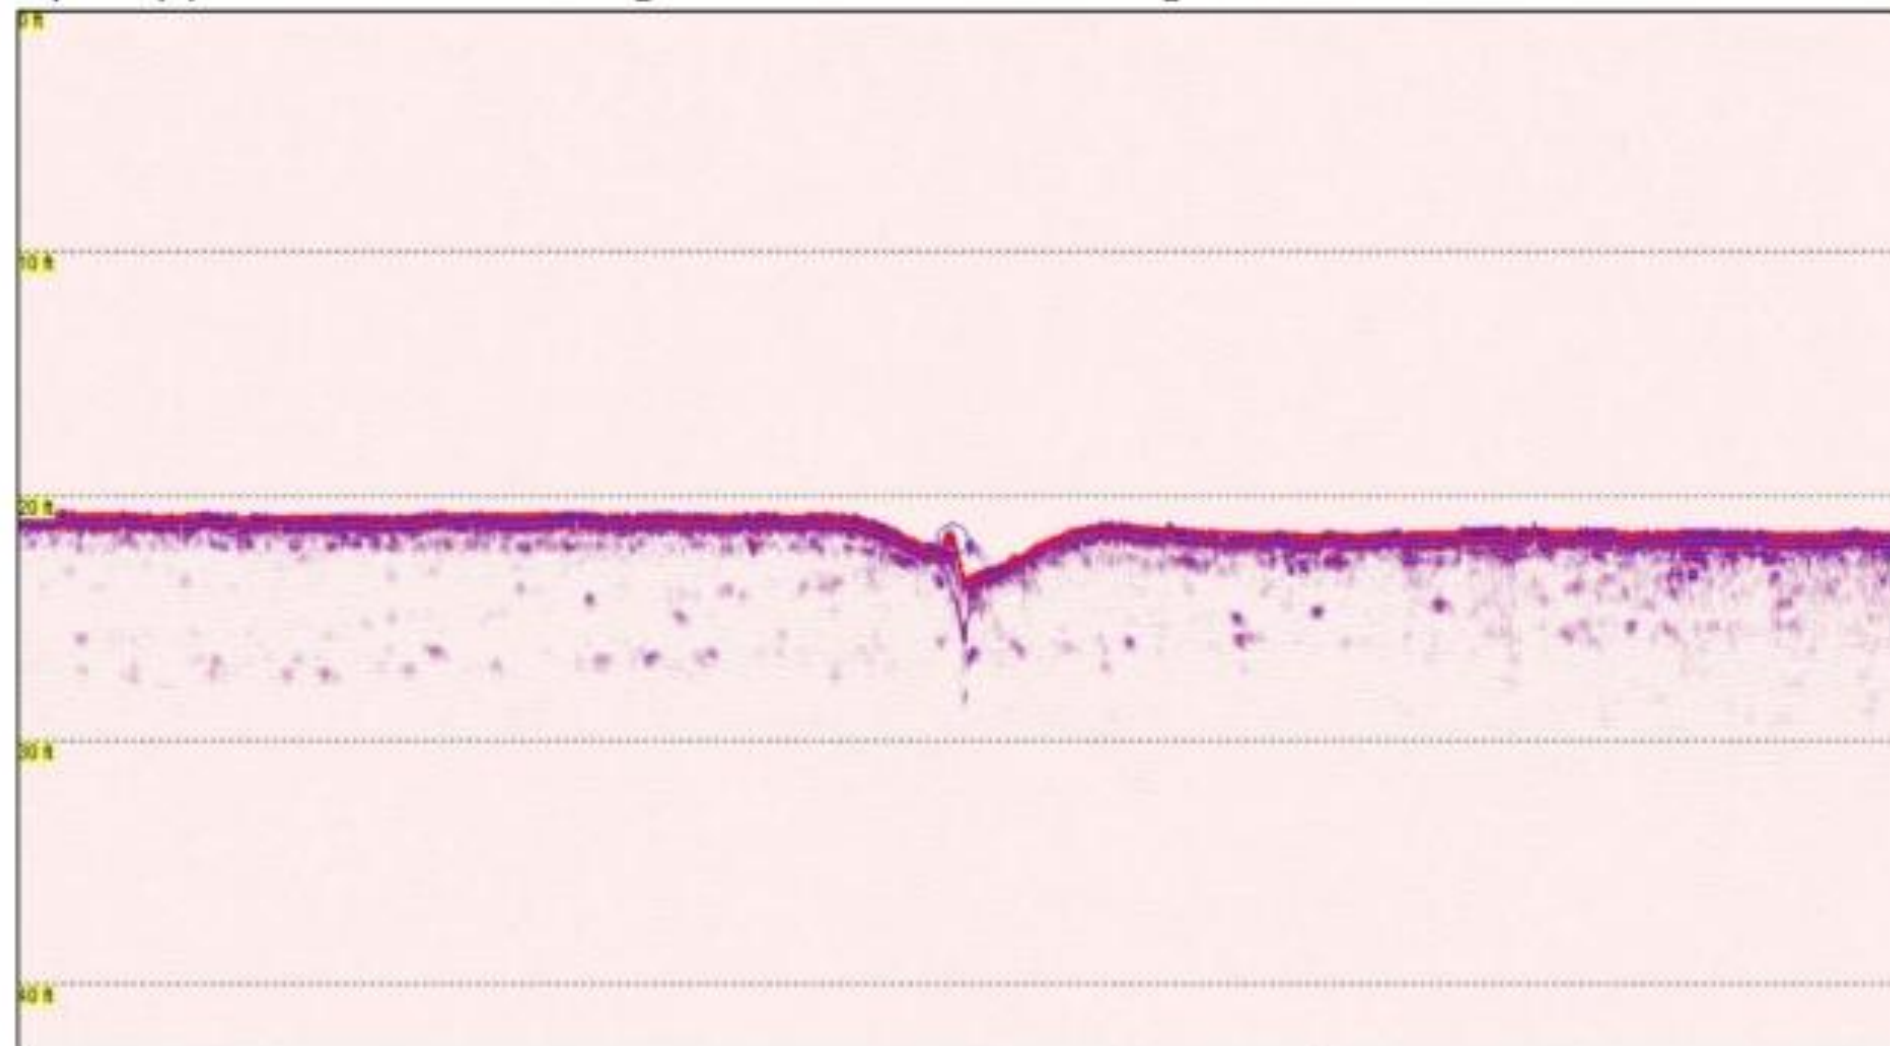
Figure 9. pipeline exposure depicted on SBP profile
