Information Item

Forcemain Inspection Program

Environment Committee: April 28, 2026

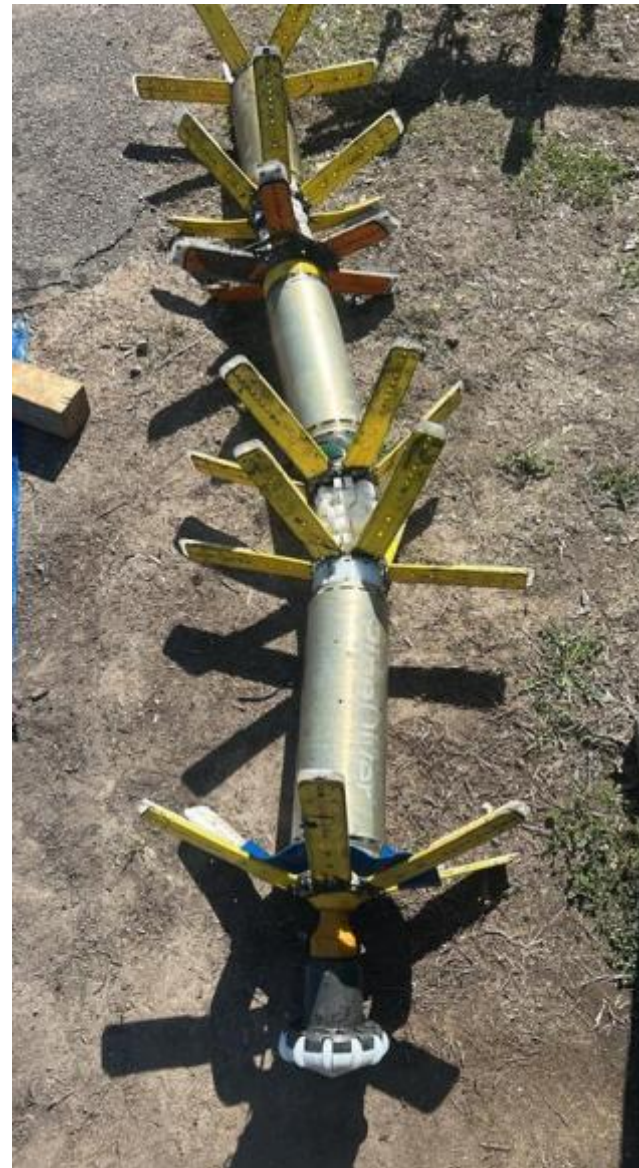
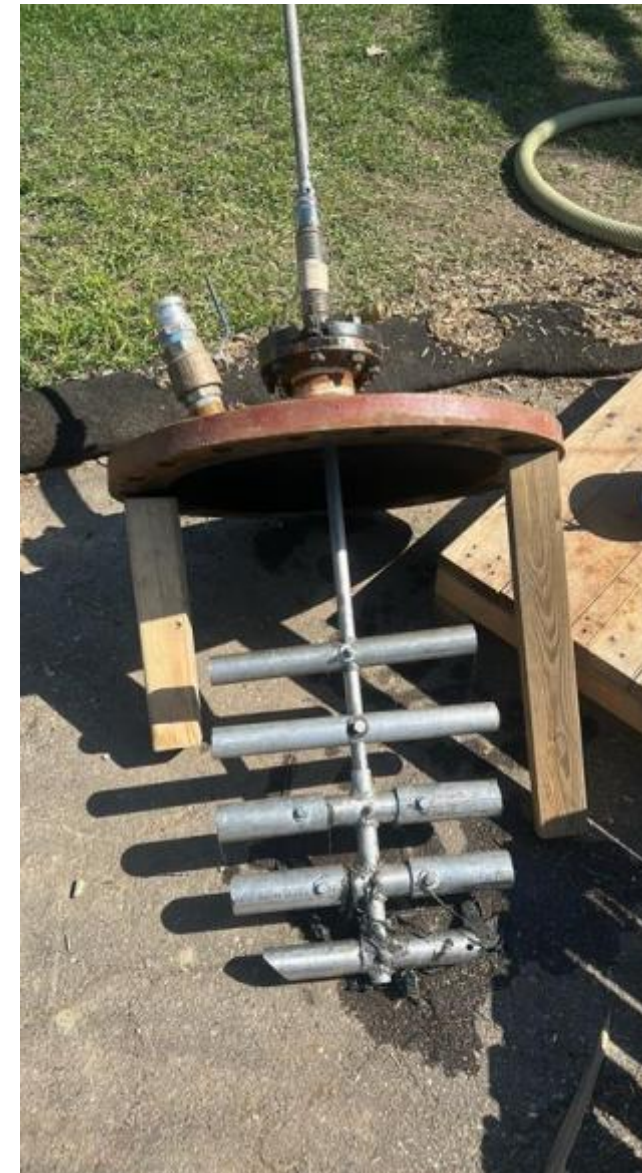
FM 7114

Electromagnetic Inspection Results

Table 2.2: Summary of Inspected Pipes				
Pipeline	Diameter (inches)	Number of Inspected PCCP Pipes	Pipes with Broken Wire Wraps	Anomalous Pipes
Golden Valley/New Hope Force Main	24	580	30	4

Table 2.3: Summary of Pipes with Broken Wire Wraps					
Pipeline	Diameter (inches)	PCCP Length (feet)	Pipes with fewer than 25 Broken Wire Wraps	Pipes with 25 to 50 Broken Wire Wraps	Pipes with more than 50 Broken Wire Wraps
Golden Valley/New Hope Force Main	24	8,710	26	4	0
